# INSPECTOR GENERAL

JULY 7, 2016

## U.S. Military-Occupied Facilities Inspection—King Abdullah II Special Operations Training Center

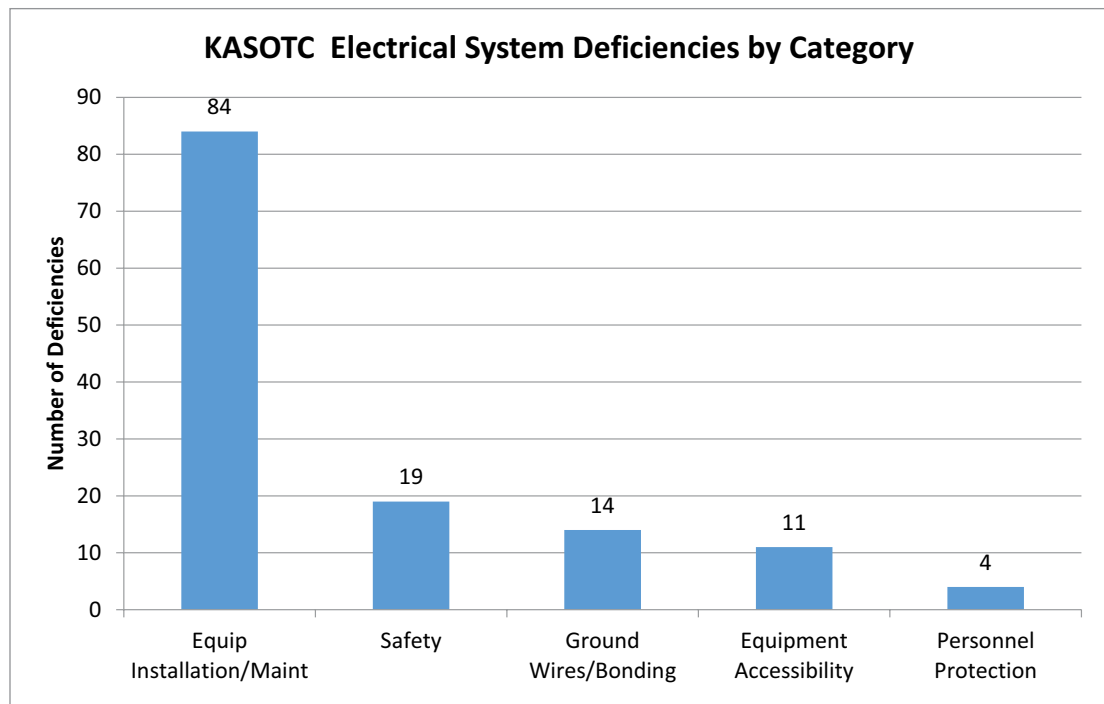
Figure 2. Electrical Deficiencies

We documented a total of 132 deficiencies (see Figure 2) related to electrical systems. Based on our evaluation, the deficiencies found were related to equipment installation and maintenance, safety, ground wires and bonding, equipment accessibility, and personnel protection, posing a risk of electrocution, injury, or death. The deficiencies included unprotected and exposed electrical wires and physically compromised lightning protection systems throughout KASOTC. The electrical systems also lacked equipment groundings and bonding jumpers at main service panels. In many instances equipment grounding was disabled or cut, suggesting a lack of proper knowledge and training of the local electricians contracted to perform installation and maintenance.

1. **Conduct a root-cause analysis and implement a corrective action plan for all electrical deficiencies identified in this report.**
2. **Create and execute a plan for ongoing inspection and maintenance of all U.S. military-occupied facilities at the King Abdullah II Special Operations Training Center and other locations where Commander, Combined Joint Operations Center-Jordan (CJOC-J) provides base operations support and inspection (BOS-I). Ensure that inspection and maintenance of these locations complies with applicable electrical codes.**

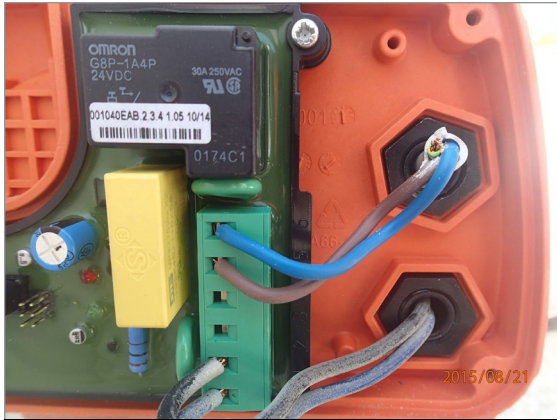
Figure 3. Water circulator motor with the ground conductor cut or missing  
(Deficiency No. KAS-EL-150828-023  
Source: DoD OIG, PO-TAD

One such critical deficiency included equipment ground conductors which were cut and not utilized, thus leading to potential shock or electrocution of tenants (see Figure 3).

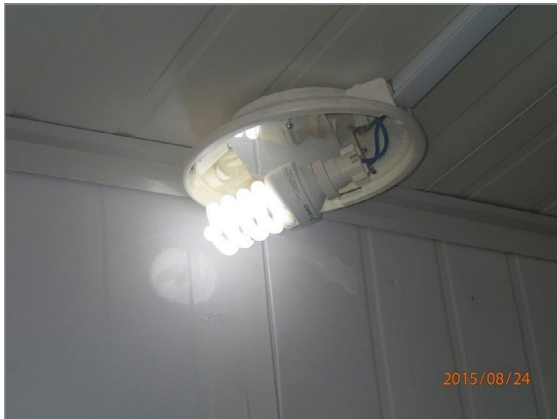
Many latrines, showers, and other bathroom areas had lighting fixtures that were not rated for use in areas that could be exposed to water or moisture. Without “wet labeled” or “damp labeled” indications, light fixtures are not suitable for use in damp conditions. If the fixtures are not designed for these conditions,

they increase the likelihood of electrocution. In many instances, light fixtures were also broken or were missing lens covers, thus exposing wiring to water, which increases the potential for electrical shock or electrocution (see Figure 4).

Figure 4. Light fixtures were missing lens covers and wiring was exposed  
(Deficiency No. KAS-EL-150828-076)  
Source: DoD OIG, PO-TAD

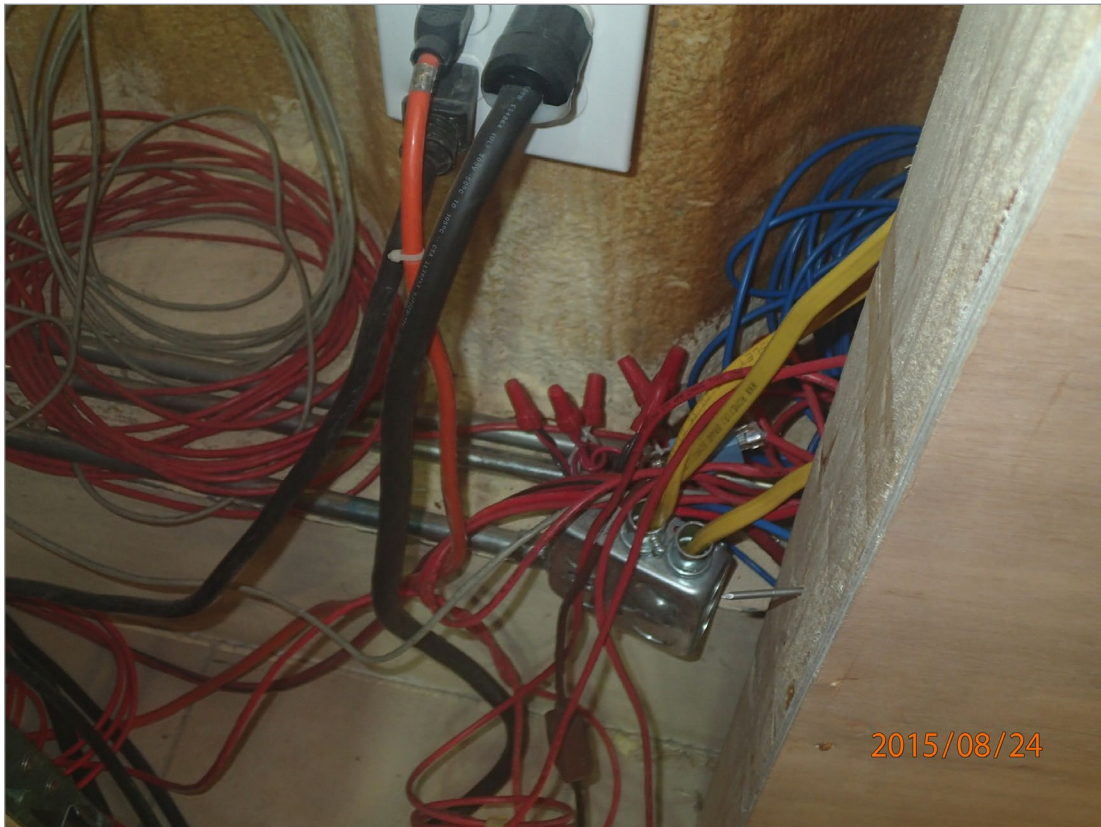
For personal protection deficiencies, we identified several receptacles where ground-fault circuit interrupter (GFCI)<sup>11</sup> protection was not used in the required areas, such as near the sink, washer, or water fountain. We also found energized wires that were not installed in junction boxes or they were installed in the junction box but were missing the covers. In addition, bare wires were connected to an electrical receptacle and electrical wire raceway covers were not installed or were broken, resulting in conductors that were lying on the floor or roof. Conductors lying loose on the floor posed a trip hazard and could be damaged, exposing bare wires, which could pose a fire hazard (see Figure 5).

Figure 5. Missing junction box with exposed energized wires (Deficiency No. KAS-EL-150828-074)  
Source: DoD OIG, PO-TAD

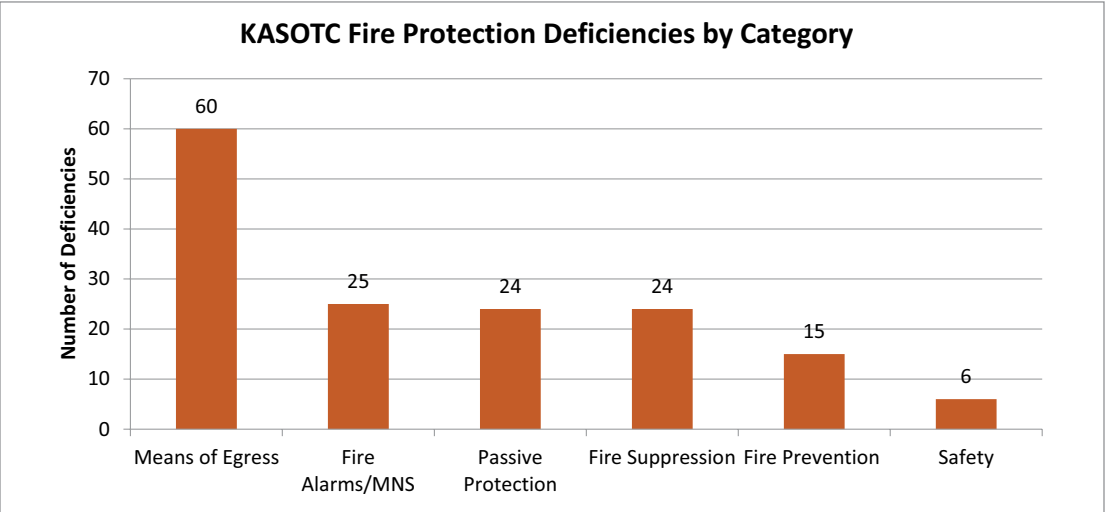
Figure 6. Fire protection deficiencies

We identified 154 deficiencies related to fire protection systems (see Figure 6). The majority of deficiencies found were related to the means of egress, passive protection, fire alarm and mass notification system (MNS), fire suppression, and fire prevention. These deficiencies in fire protection systems pose a significant risk of fire and loss of life or property.

1. **Conduct a root-cause analysis and implement a corrective action plan for all fire protection deficiencies identified in this report.**
2. **Create and execute a plan for ongoing inspection and maintenance of all U.S. military-occupied facilities at the King Abdullah II Special Operations Training Center and other locations where Commander, Combined Joint Operations Center-Jordan (CJOC-J) provides BOS-I. Ensure inspection and maintenance of these locations complies with applicable fire protection codes.**

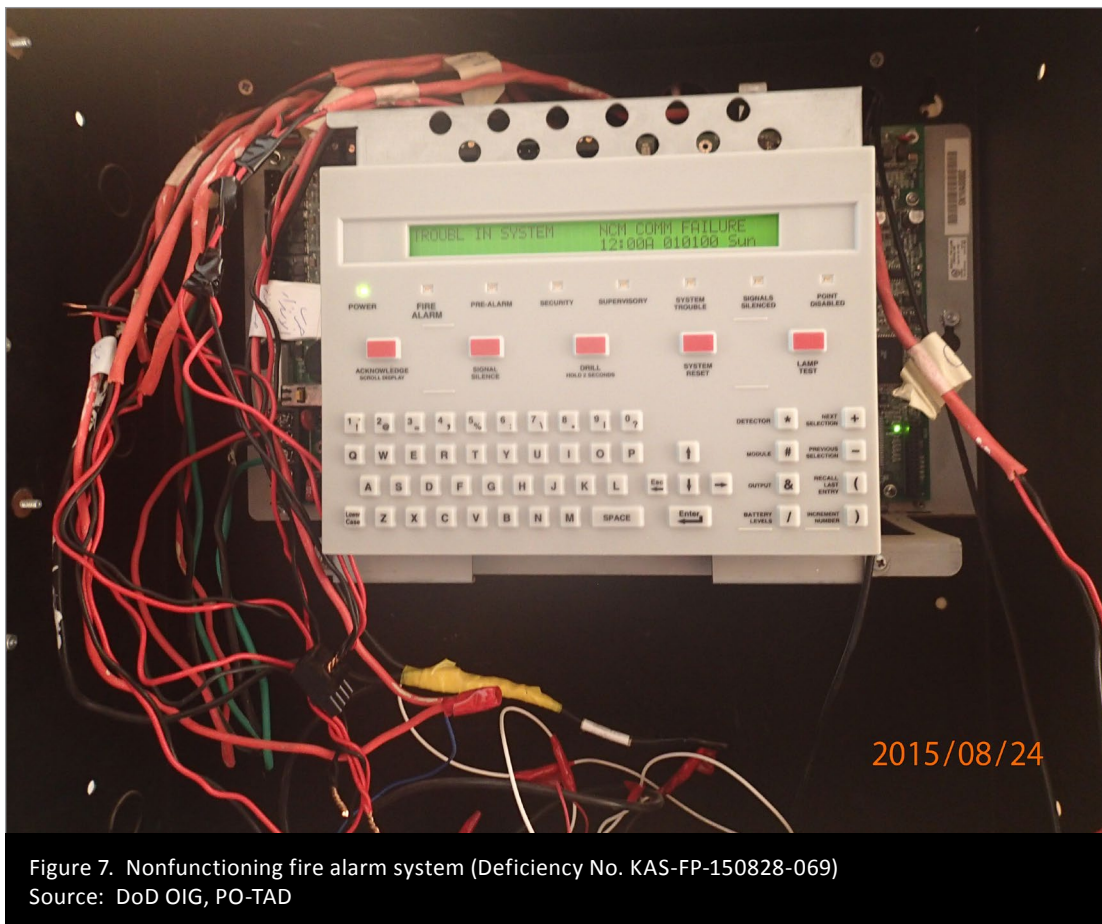
We found six facilities that were not equipped with fire alarm systems, three facilities with fire alarm systems that were completely off or out of service, and three facilities with partially-functioning fire alarm systems (see Figure 7).

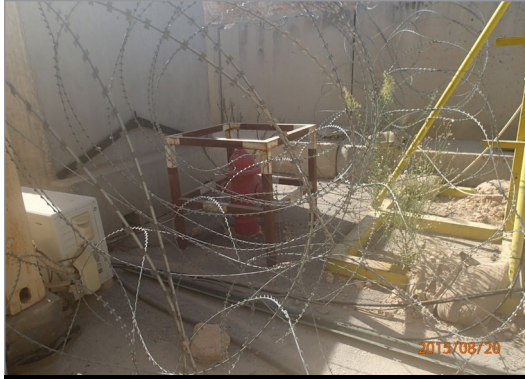
Figure 8A. Fire hydrant obstructed and inaccessible by concertina wire (Deficiency No. KAS-FP-150828-137)  
Source: DoD OIG, PO-TAD

We found fire hydrants that were blocked by concertina wire, buried in concrete, placed below the ground surface, and/or tapped as a nonfire-related source of water (see Figures 8A and 8B). Also, there was a lack of fire hydrants in close proximity to several buildings.

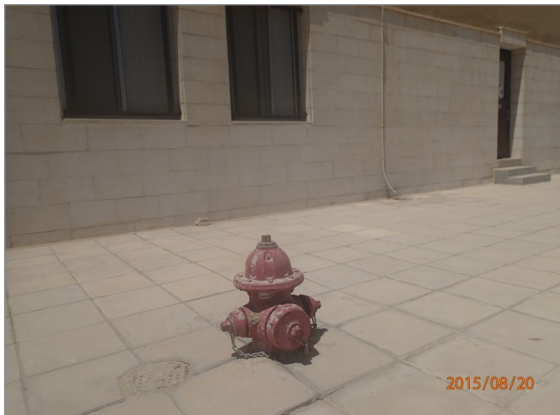
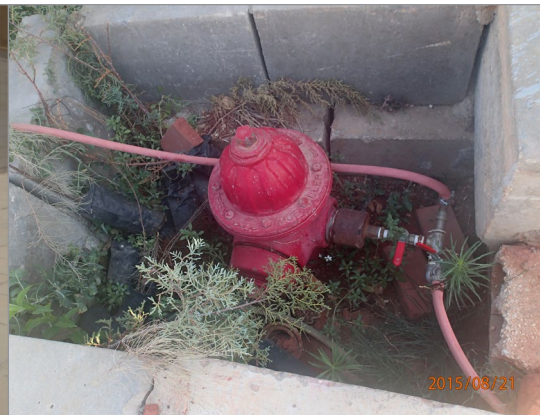
Figure 8B. Fire hydrant buried in concrete and tapped (Deficiency No. KAS-FP-150828-034)  
Source: DoD OIG, PO-TAD

These compromised fire hydrants could significantly delay or prevent firefighter response in the event of fire.

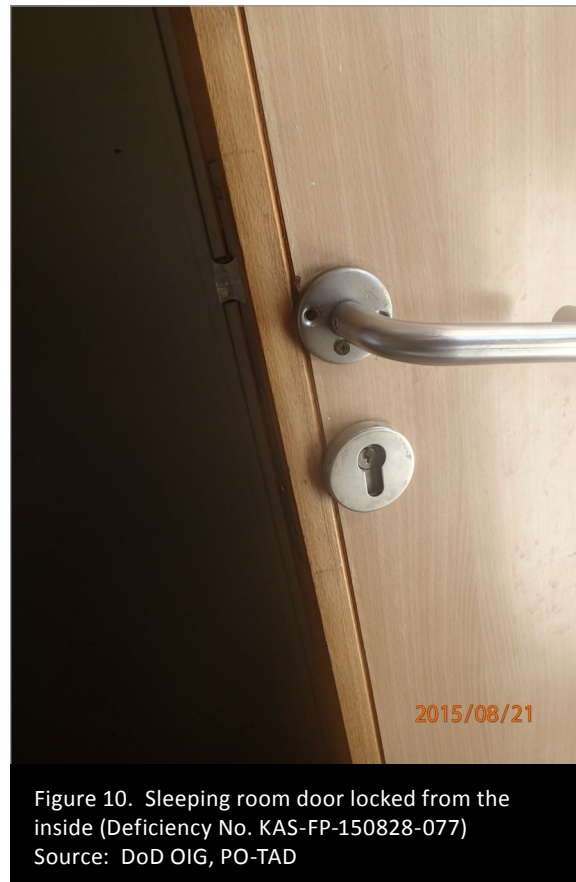
We also found that many doors from sleeping rooms required the use of a key to exit. The locked doors could potentially prevent a person from escaping in the event of an emergency (see Figure 10).

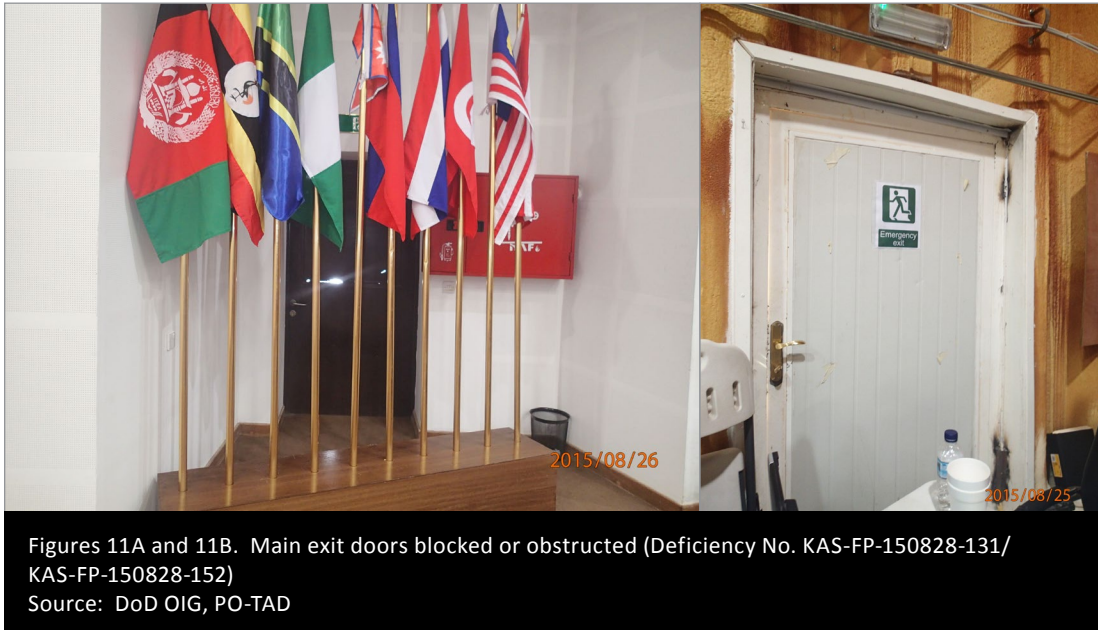
We found rear exits obstructed or blocked, which could slow the occupants' exit during a fire (see Figures 11A and 11B).

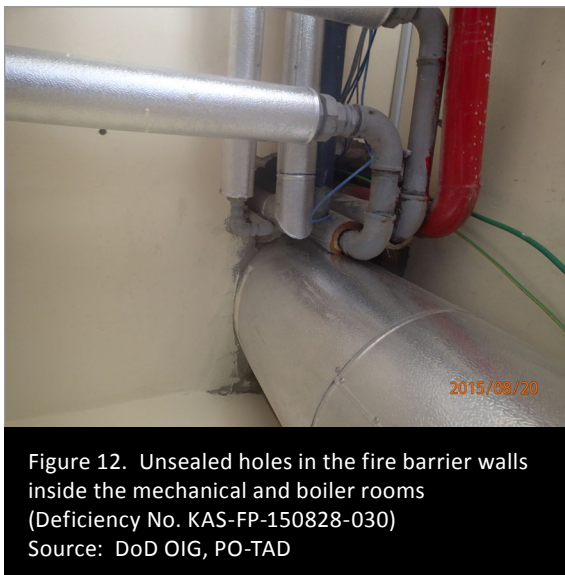
with diesel fuel equipment did not have carbon monoxide (CO) detection devices or exhaust fan systems. These issues impair the occupants' ability to be made aware of an emergency and safely exit the building in the event of an emergency. We also found numerous unsealed fire wall penetrations due to cable conduits routed through unsealed holes in fire barrier walls in mechanical and boiler rooms, creating a means for fire and smoke to propagate throughout the building (see Figure 12).

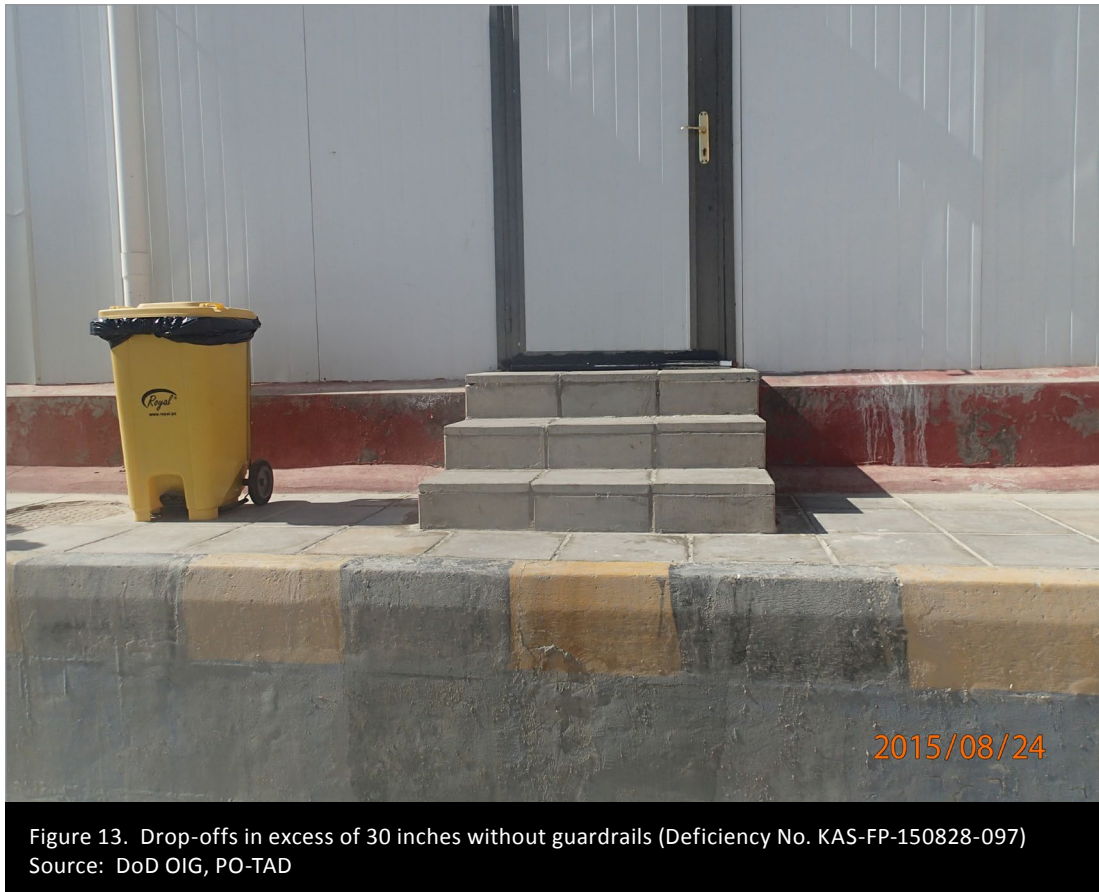
On one of the egress routes, we found drop-offs in excess of 30 inches without guardrails. Occupants could fall over the ledge and injure themselves (see Figure 13).

Figure 13. Drop-offs in excess of 30 inches without guardrails (Deficiency No. KAS-FP-150828-097)  
Source: DoD OIG, PO-TAD
