# INSPECTOR GENERAL

JULY 7, 2016

## U.S. Military-Occupied Facilities Inspection—King Abdullah II Special Operations Training Center

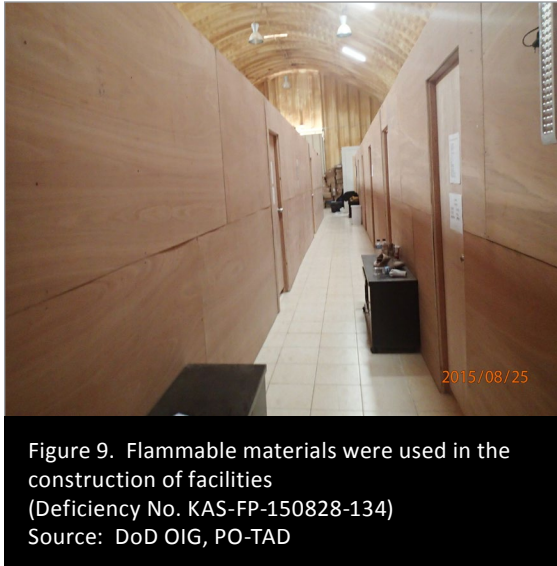
We found that four sleeping quarters had flammable foam insulation on the walls and ceiling that was not encapsulated, and that seven facilities had used non-fire-rated plywood to construct corridor walls and fire exit doors (see Figure 9). We burned a piece of the spray foam used on the walls and the ceiling and found that it produced a thick black smoke when burning. The use of flammable materials could compromise the means of egress through these corridors and could create toxic smoke in the event of a fire.

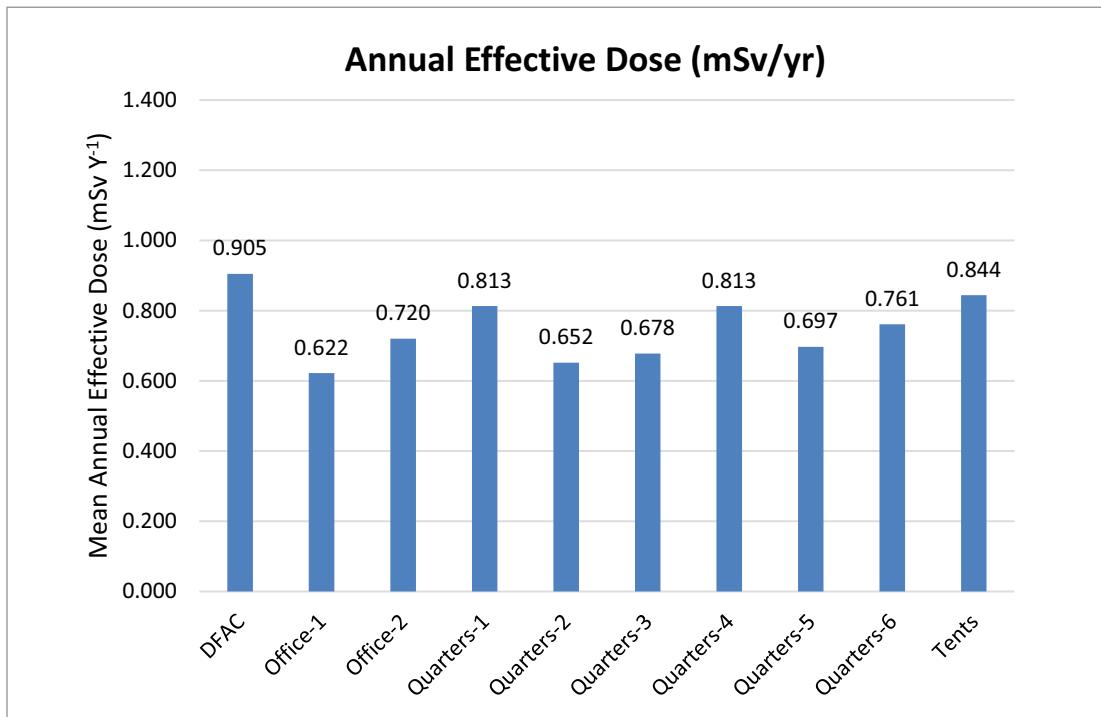
Figure 14. Estimated annual mean effective dose for individual at KASOTC

The determined annual mean effective dose values for each location inspected are shown graphically in Figure 14. Determined mean values were all less than a 1.0 mSv annual effective dose. The overall mean dose was determined to be 0.76 mSv. The results of this assessment suggest that the mean effective dose an individual receives from external background radiation in one year while assigned to KASOTC is less than 1.0 mSv. Currently, there are no regulatory dose limits from external, naturally occurring background radiation exposure.
